Fluke ii910 Precision Acoustic Imager

A fast, easy way to detect, locate and analyze partial discharge in one tool.

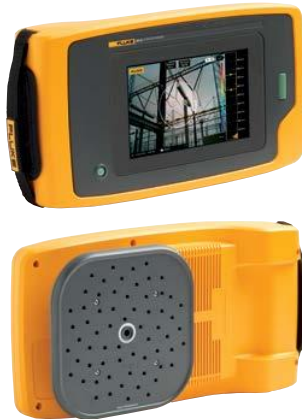
Fluke ii910

- 17.78 cm (7 in) 1280 × 800 LCD with capacitive touchscreen
- Detection range of 0.5 m to 120 m
- Frequency band of 2 kHz to 100 kHz
- SoundMap™ overlay for visual PD detection
- Captures videos in MP4 format
- Manual frequency filtering
- Two-year warranty

Key Features		ii910
Sensor		
Frequency Band		2 kHz to 100 kHz
Nominal Frame Rate		25 fps
Detection Range		0.5 to 120 m (1.64 to 393.7 ft)
Built-in Digital Camera (visible light)		
Field of View		63° ±5°
Focus		Fixed lens
Display		
Size		22.86 cm (7 in) LCD with backlight, under-sunlight readable
Resolution		1280 × 800 (1,024,000 pixels)
Touchscreen		Capacitive
Acoustic Image		Yes, SoundMap™ image
Acoustic Measurements		
Measurement Range		12.1 dB SPL to 114.6 dB SPL ±1 dB SPL 2 kHz 4.4 dB SPL to 101.2 dB SPL ±2 dB SPL 19 kHz 12.8 dB SPL to 119.2 dB SPL ±1 dB SPL 35 kHz 19.8 dB SPL to 116.1 dB SPL ±3 dB SPL 52 kHz 41.4 dB SPL to 129.0 dB SPL ±1 dB SPL 80 kHz 54.4 dB SPL to 135.5 dB SPL ±1 dB SPL 100 kHz
Auto Max/Min dB Gain		Auto or manual, user selectable
Frequency Band Selection		User selectable through user-made pre-sets or manual entry
General Specifications		
Battery Life		6 hours/battery (product includes spare battery)
